SERVICE BULLETIN #10

SUBJECT: Sea Water Pump Clearance and Alignment

MODEL: Westerbeke 40 and WPDS 10-15

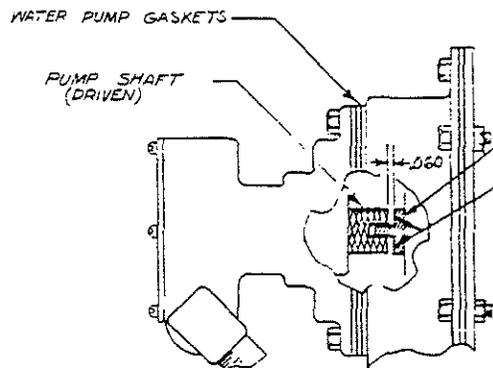
Adequate longitudinal clearance between the sea water pump shaft and the driving shaft is established by the use of multiple pump gaskets. The number of gaskets required can vary from 1 to 4. Enough gaskets must be used so that the shaft ends do not mate. See figure 1.

The application of liquid or paste type Prussian blue (at points indicated by arrows) will give positive indications of pump drive contact which will require the use of additional gaskets.

If the proper clearance is not maintained, the sea water pump shaft will force the fuel pump drive hub against its bushing. The bushing will seize to the drive hub and rotate in its housing. Bushing wear and loss of oil pressure will result.

When replacing the sea water pump be sure that the same number of gaskets is replaced and there is the required clearance.
